Energy Audit Magnus Theatre 10 South Algoma Street Thunder Bay, ON

November 14, 2014

Pinchin File: 88911

Report: Energy Audit
Magnus Theatre, 10 South Algoma Street
Thunder Bay, ON

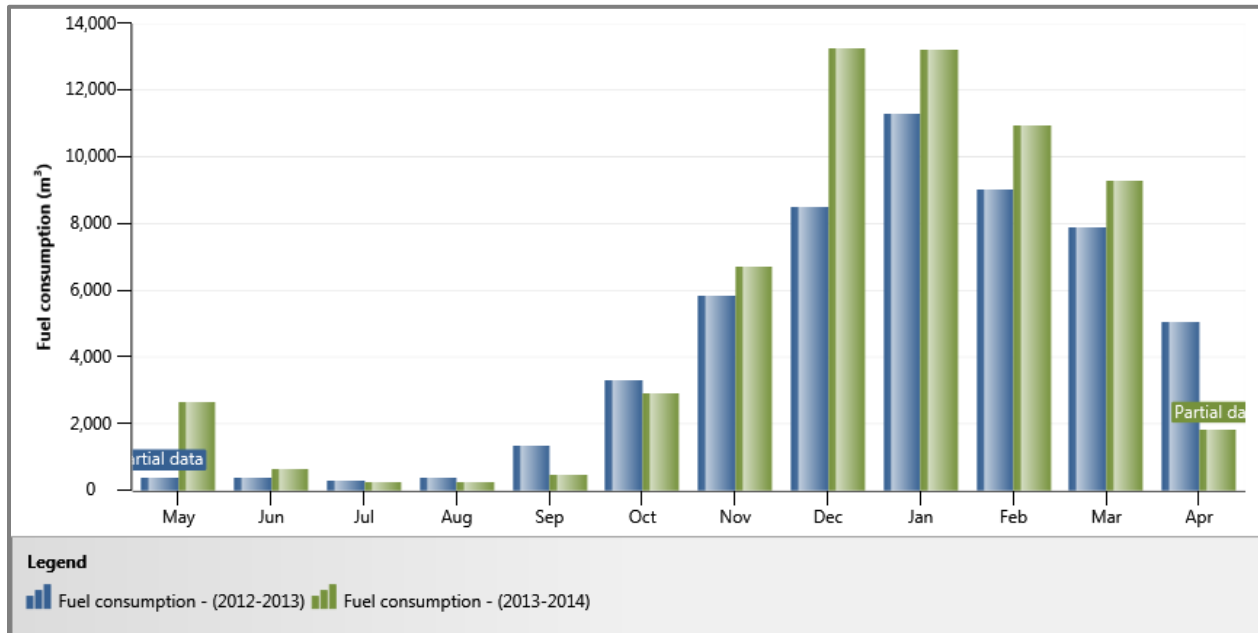
Figure 2: Natural gas consumption (m3)

Figure 2 highlights the seasonality of natural gas use on the site. The peak in usage from October to April is assumed to be for space heating purposes while the summer baseline of 300 m³ is assumed to be used by the domestic hot water system.

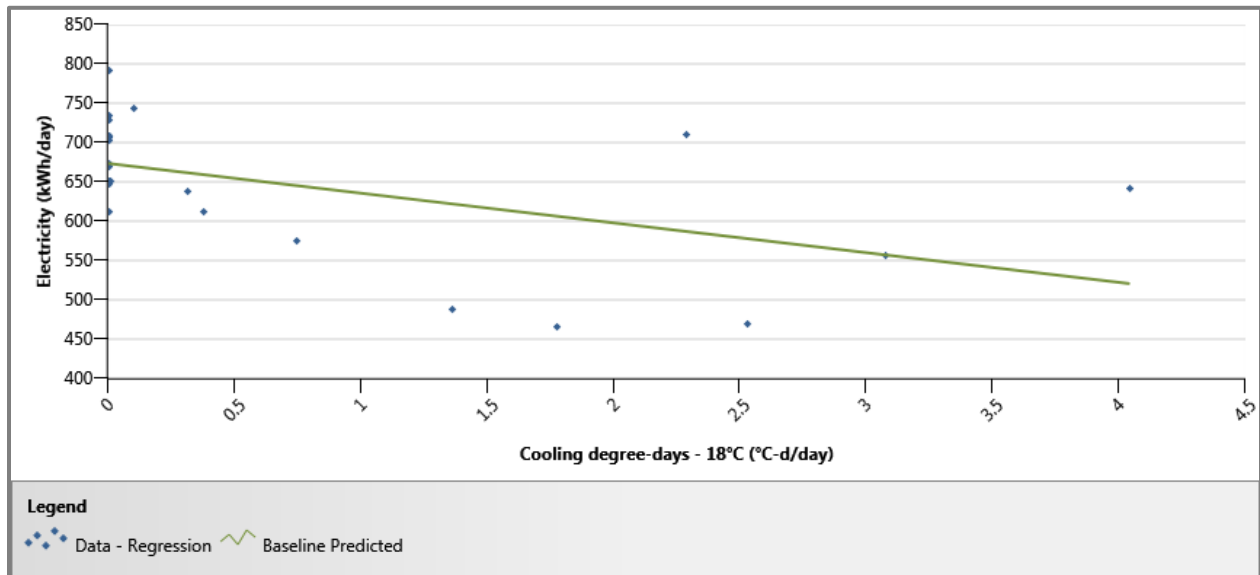
Figure 5: Electricity and Cooling Degree Day Regression Analysis

The regression analysis for electricity and cooling degree days indicates that cooling is not a significant source of electricity use and is marginal in comparison to the heating electricity use.

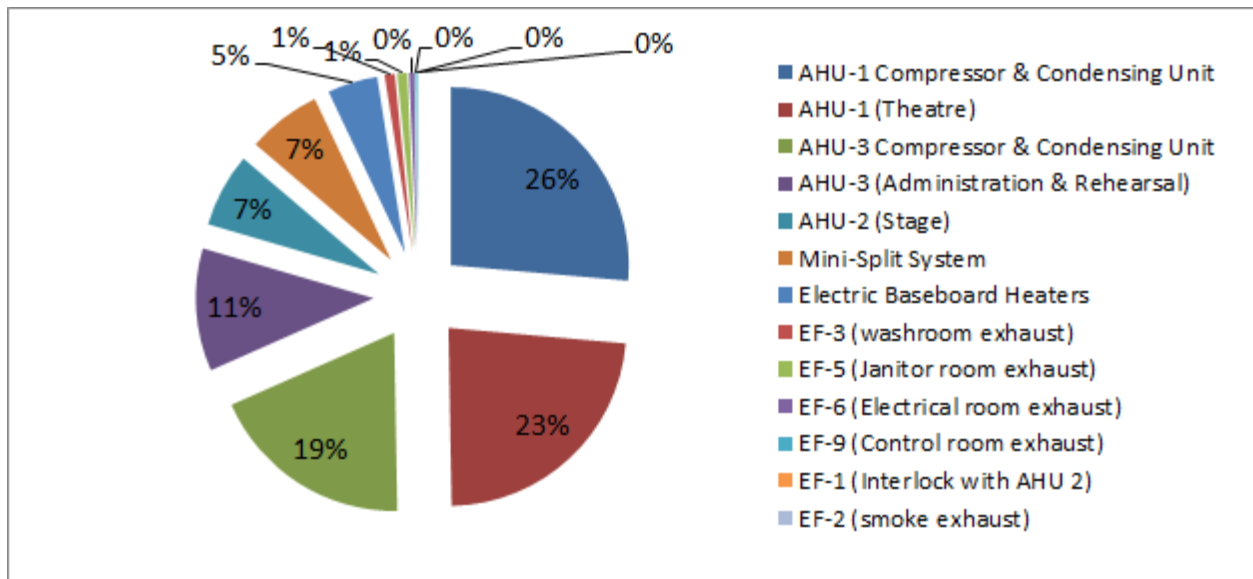
Figure 9: Breakdown of HVAC electricity use on site

The primary consumer of HVAC electricity are electric motors used to move air in the air handling units (AHU) and exhaust fans as well as the electric motors that power the air conditioning system via the compressors in the rooftop condensing units.

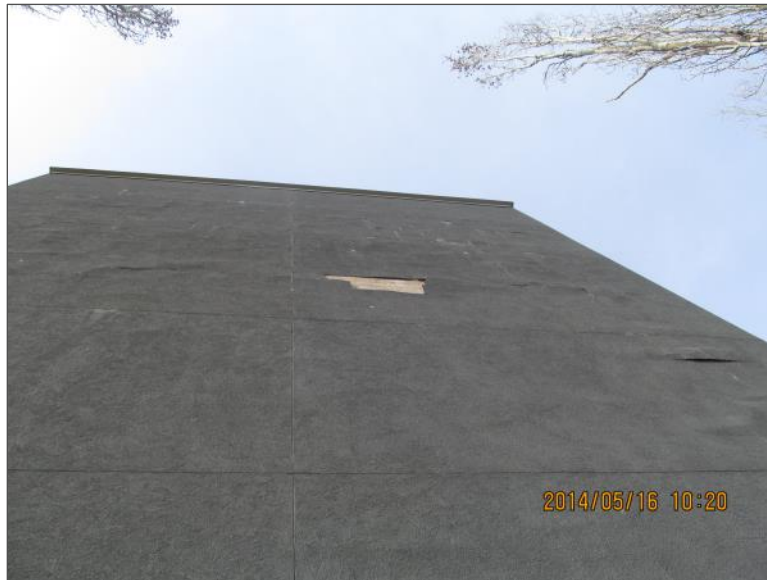
During the site visit the exterior coating on the Durisol Block Wall on the new addition was observed to be systematically failing. Larger portions of the coating were losing adhesiveness and falling off the block wall.

Example of the exterior coating on the Durisol Block wall failing.

A full investigation by an architect or building scientist is required to determine the exact cause of the premature failure.

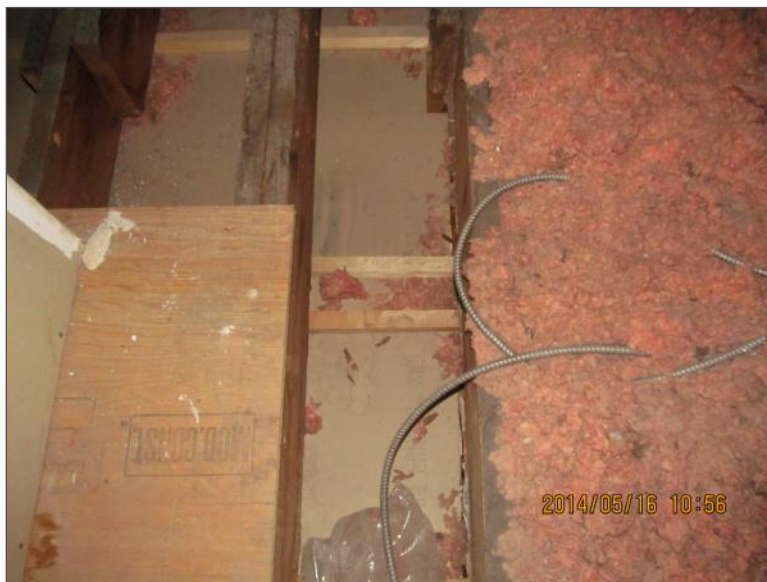
Existing System: The existing insulation system in the original building attic space is loose batt insulation approximately 4" thick. During the site visit Pinchin observed areas in the attic floor (where the insulation is located) that were uncovered with clear views of the second floor.

Example of attic insulation not providing full coverage of the second floor ceiling.

Recommendation: Pinchin recommends removing and disposing of the existing insulation. While the insulation is removed, holes and gaps between the second floor and attic should be sealed. New insulation should strive to achieve an R-value of 49 or higher. This corresponds to approximately 14" of loose cellulose insulation, 15" of fibreglass batt insulation or 20" of loose fibreglass insulation.

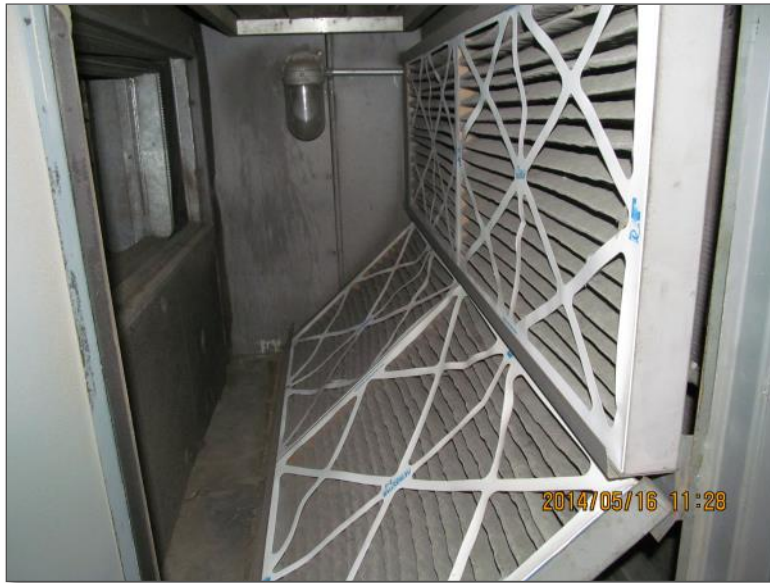
Existing System: During the site visit Pinchin observed air filters that were dirty and need replacing. Dirty filters add to the static pressure loss in air systems which have a negative impact on fan performance.

Example of dirty air filters in the AHUs.

Recommendation: Pinchin recommends inspecting the filters on a quarterly basis and changing the filters when they become dirty.

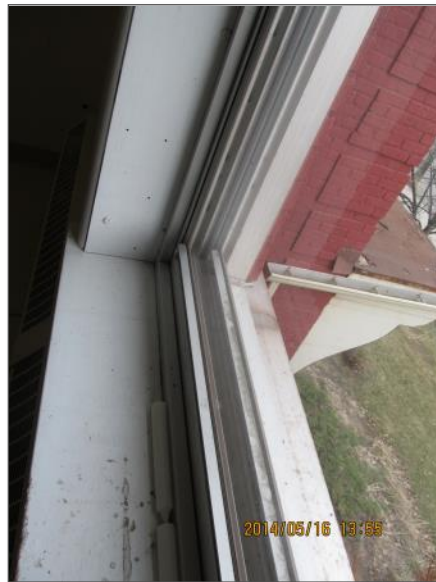
Example of the original double hung windows and evidence of condensation deteriorating the wood window sill.

Recommendation: Replace all existing windows with triple pane low e coating windows with a R-Value of approximately 7.5

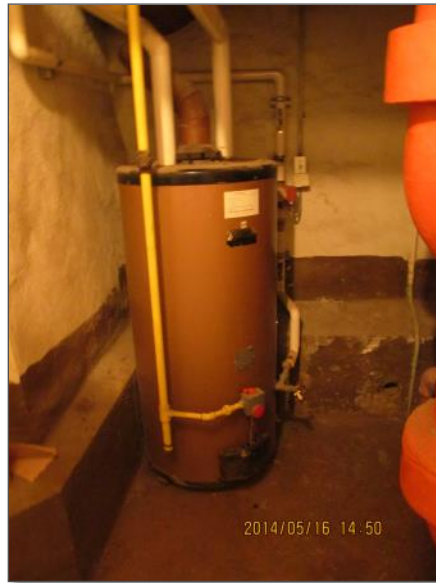
Existing System: The existing domestic hot water heater is a 95,000 BTU/hr natural gas fired heater with a capacity of 80 US Gallons with a thermal efficiency of approximately 80% and a system efficiency of approximately 60%.

Example of the existing DHW with a thermal efficiency of approximately 80%. New condensing DHWs have thermal efficiencies approaching 97%.

Recommendation: Pinchin recommends upgrading the DHW heater and storage tank to a condensing model with thermal efficiencies approaching 97% and a system efficiency of 86%
