# ENERGY ASSESSMENT REPORT

## Museum London, London, Ontario

Originally Issued: May 23<sup>rd</sup>, 2014

Revised: July 2<sup>nd</sup>, 2014

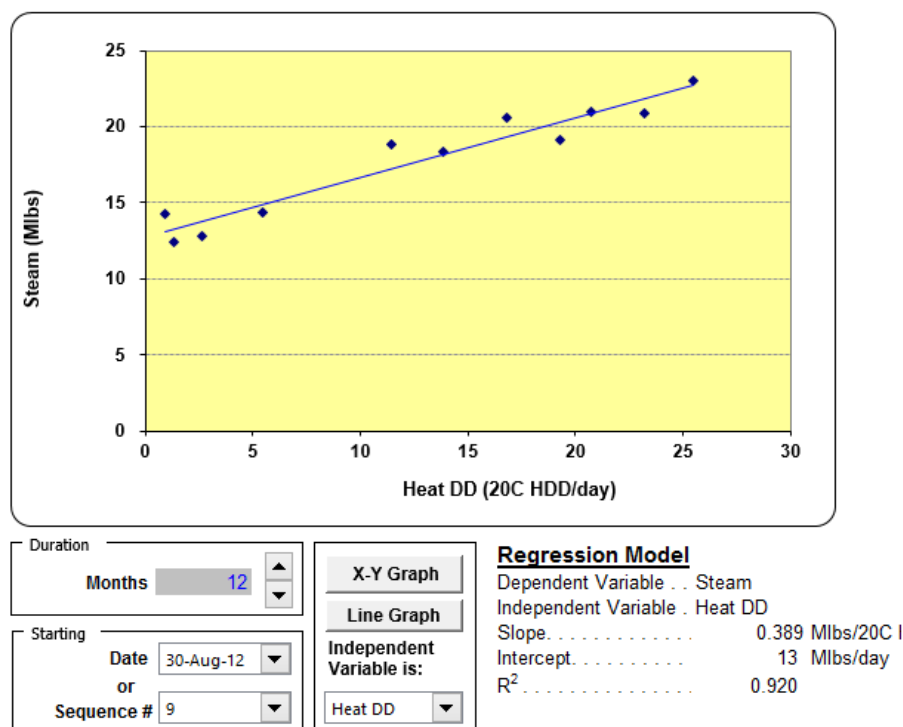
**Figure 13:** Linear analysis for the period starting February 2012 to December 2013

The base load for the facility is shown at the intercept of the 'Y' axis and zero Heating DD. The base load of 13 Mlbs/day (approximately 390 Mlb/month) is not weather sensitive and probably indicates the steam used to heat the domestic hot water tanks, as well as any constant base humidification.

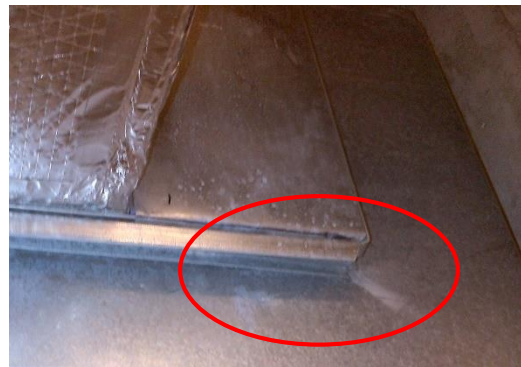
In addition to the areas mentioned above, ducts located in a storage room (Room 132) by the main floor workshop had unsealed sections (please see photo to right in which daylight was visible). The staff mentioned occasional mold problems on the wall near this unsealed vent. We believe that this could be contributing to the mold issue if moist air enters the space from the outside and condenses on the uninsulated brick causing moisture issues. Additionally, this type of issue can significantly impact the temperature and humidity in the space causing increases in heating and cooling. In the same location, it was noted that the walls were not insulated.

**Figure 18:** Unsealed Ducting Showing Light from Outside.

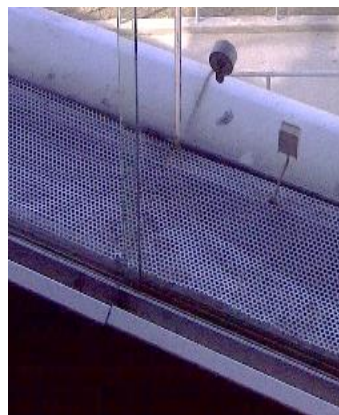
We have estimated the current heat loss through the window to be approximately 19,000 Btu/hr when the outside temperature is 7F and the indoor temperature 22C. This heat loss is reduced to approximately 2,200 Btu/hr with a triple glazed, argon filled energy efficient window. The cold glazed surfaces are conducive to moisture formation (which was also observed during the audit). In the summer months the existing window will contribute to the cooling load by excessive heat gain. We have estimated the heat gain to be approximately 29,000Btu/hr. If the window was replaced with a triple glazed, argon filled design, the heat gain would fall to 16,000Btu/hr.

**Figure 19:** Bottom of 50' long window on West wall of upper gallery. Two separate single panes.

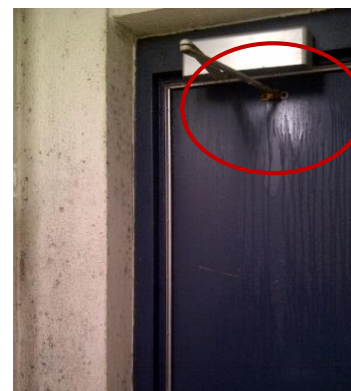
**Figure 20:** Fire Egress Door with Condensation

It will be necessary to replace the weather stripping on all the external doors (both fire and employee exit doors) to reduce drafts (infiltration).

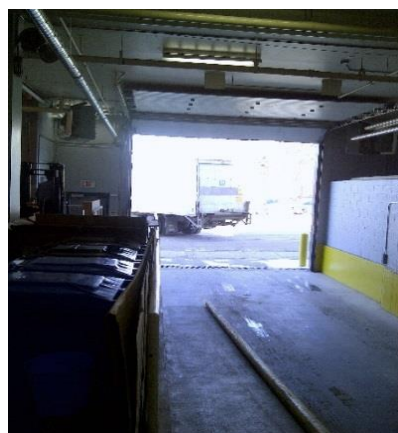
**Figure 21:** Loading bay area.

The dock area is not serviced by the Museum's HVAC system however there are two unit heaters by the access door as shown in Figure 21 above. Also visible is the fume exhaust system. The audit team noted that the heaters were running continuously and the loading bay was cold. This creates cold walls in the adjacent rooms thus raising their heating requirements.

Several alternatives were reviewed below however the only cost effective option is to turn down the set point on the two hydronic unit heaters to 16C (60F). For every 1C of setback, one can expect between 3-4% HVAC savings for the space in question. During the audit, the unit heaters were set at 20C.

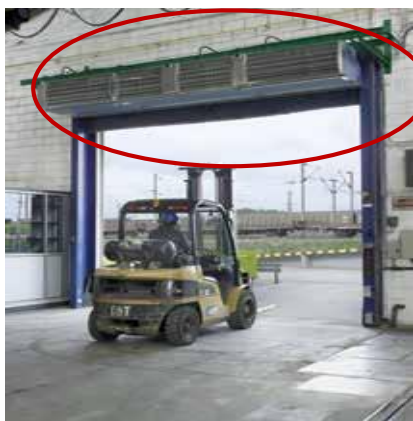
**Figure 22:** Typical air curtain installations

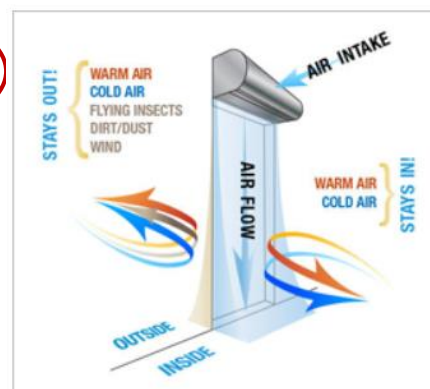
A potential solution to this issue would be to install a horizontally mounted air curtain above the access to prevent the ingress of the external cold air (as shown in Figure 22 above). This would reduce the heating demand in the loading bay and prevent the common interior walls from becoming cold surfaces.

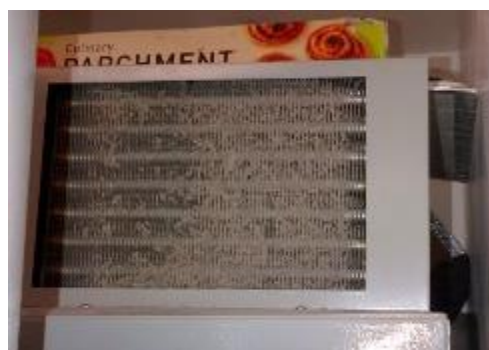
Dusty compressor coils on fridges and freezers will cause the compressor to run longer and therefore increase electricity consumption. The coils should be vacuumed twice a year.

**Figure 24:** Ice Freezer Compressor Coils in Rhinoceros Lounge Kitchen

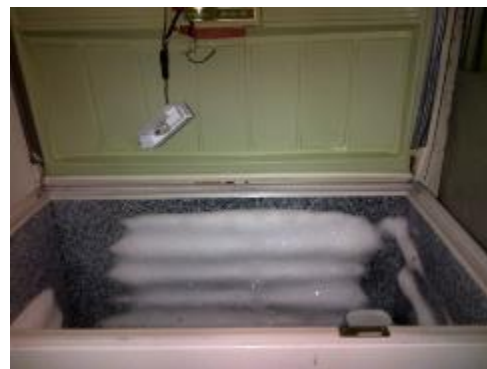
The majority of appliances appear to be in good working condition so upgrades to newer appliances would not be advisable until the current appliances require replacing. One exception was noted by the auditors in the second floor catering kitchen. An older model chest freezer had a significant layer of frost covering the inside surface and was essentially empty. It is used when functions held in the upper galleries require use of the catering kitchens. This appliance should be replaced with a new Energy Star rated freezer appropriately sized for the current catering requirements.

**Figure 25:** Chest Freezer located in Upper Gallery Catering Kitchen

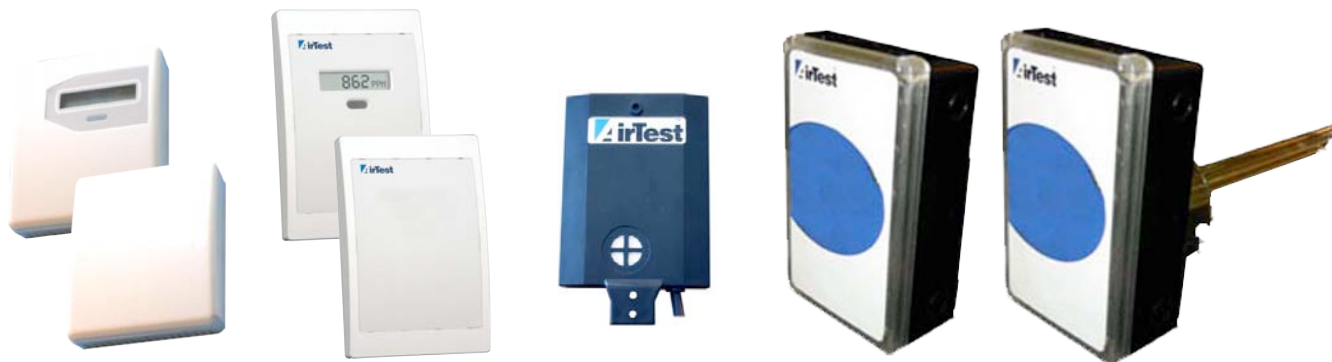
## Self Calibrating - CO<sub>2</sub> Transmitters

Wall Mount  
TR9290

Wall Mount  
TR9294

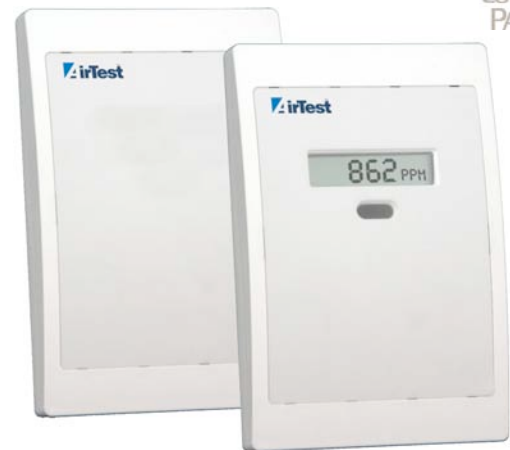
TR9294-Lon      TR9294-L-Lon

**Description:** This LonWorks<sup>®</sup> output is only available for the AirTest Model TR9294 wall Mount CO<sub>2</sub> Transmitter. These sensors are all self-calibrating and will not require any maintenance for the life for the sensor (typically 15 years). These sensors provide a CO<sub>2</sub> ppm & % SNVT for 0-2000 ppm CO<sub>2</sub>. Other ranges up to 0-10,000 can be factory set.

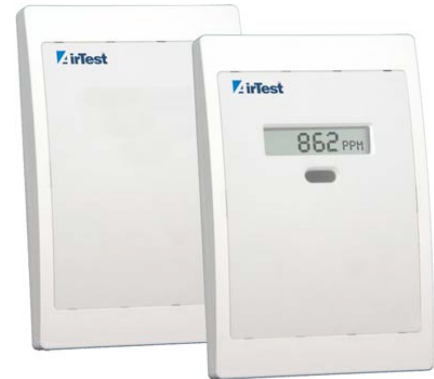
TR9294-?-BAC TR9294-?-L-BAC

This BacNet® output is only available for the AirTest Model TR9294 wall Mount CO<sub>2</sub> Transmitter. These sensors are all self-calibrating and will not require any maintenance for the life for the sensor (typically 15 years). These sensors provide a CO<sub>2</sub> ppm output object for 0-2000 ppm CO<sub>2</sub>. Evaluated by the BACnet® Interoperability Testing Service (BITS), BACnet® Testing Laboratory (BTL) Certification in progress.

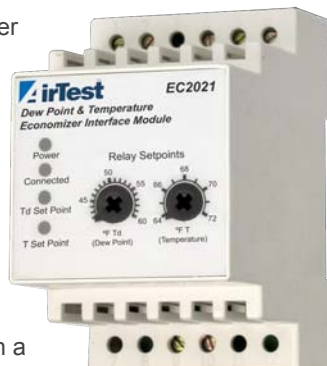
AirTest probes will easily communicate with networked building control systems but may not be compatible with stand-alone economizers. AirTest will soon be introducing the EC2021 Economizer Control Interface module that will utilize a probe output and provide analog and relay outputs for dew point and temperature that can interface to an economizer controller. Two adjustable pot screws can be positioned to the desired temperature and dew point set points. The status of the module is provided by four indicator lights. The module is DIN rail mountable or easily mounted in a standard electrical enclosure.
