ENERGY ASSESSMENT REPORT

Palace Theatre, London, Ontario

June 16, 2014

BLUE SKY
Energy Engineering & Consulting Inc.

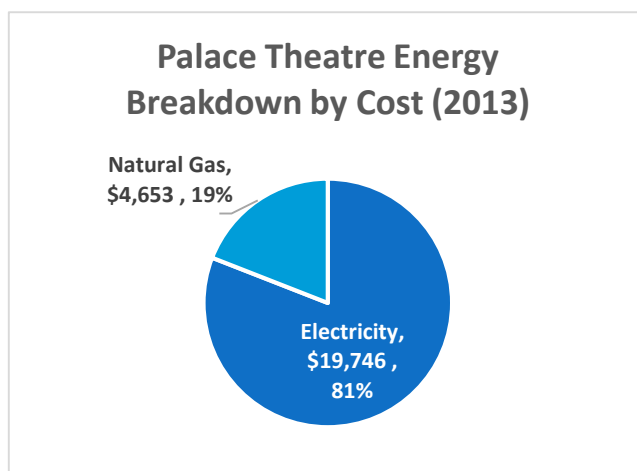
Figure 1: Total Energy Cost 2013 Broken Down by Source

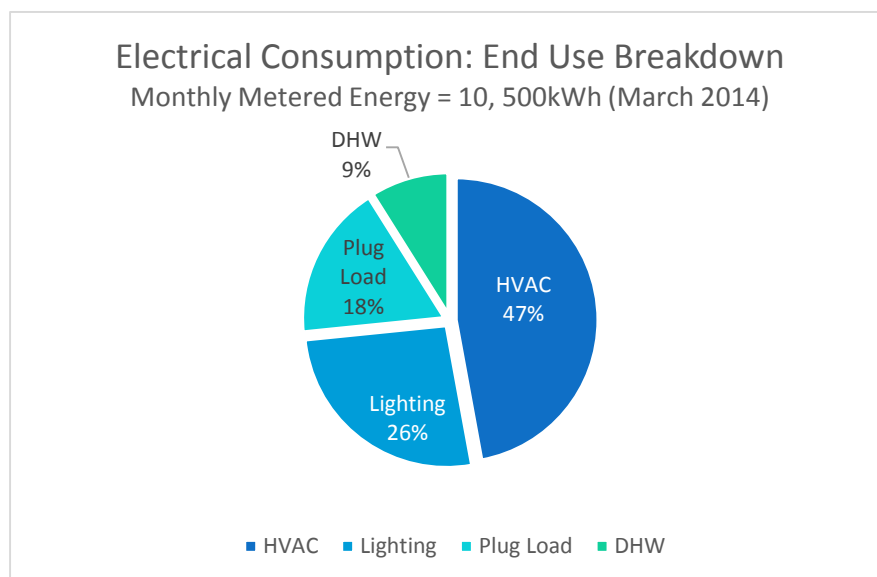
equipment in operation during the audit, and therefore is representative of a winter period breakdown. It would be expected that the HVAC consumption would be a larger factor in the summer period due to increases in chiller load.

Figure 2: Electricity Consumption Breakdown by Equipment Type

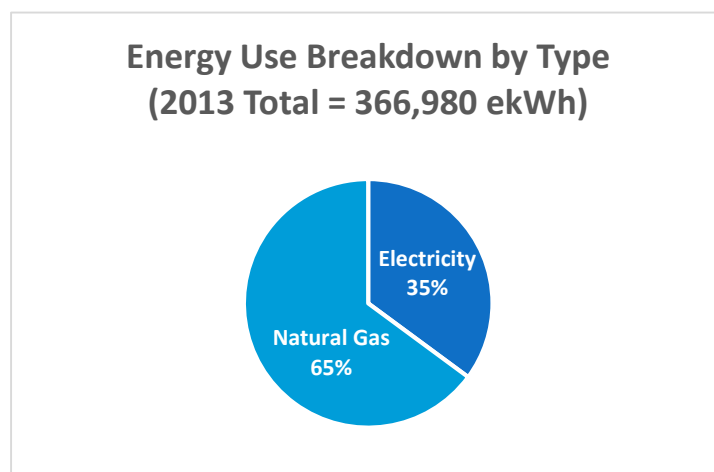
Figure 3: Total Annual Energy Consumption (ekWh) Broken Down by Source (2013)

It is interesting to note that although 65% of the total energy is provided by Natural Gas, it only represents 19% of the total energy bill.

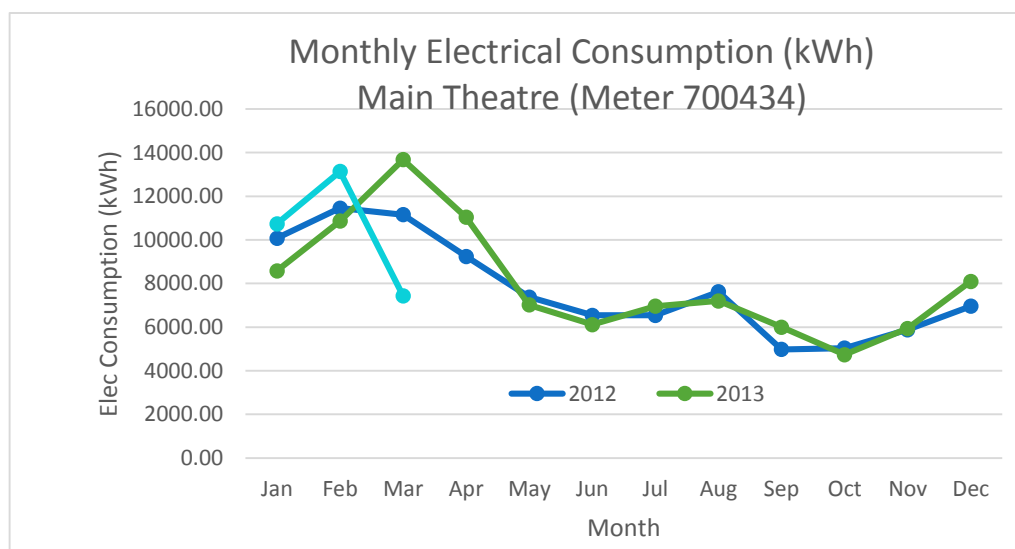
Figure 4: Historical Monthly Electricity Consumption (kWh): Main Theatre

The peaks in electricity from January to April reflect the Palace theatre's production season in which theatre lighting is a large consumer. Electrical unit heaters in the change rooms and a baseboard located in the lobby

also contribute significantly in winter months. The summer has a smaller rise in electricity use in the July / August period which is most likely influenced by the use of the chiller to condition the space. It is not a significant a rise in the summer due to the limited operating hours of the theatre at that time. The staff only run the chiller when the space is occupied.

It would be useful for the staff to complete an assessment both in the daytime and at night, during the summer months when the theatre is not in use. The objective would be to look for systems (lighting, A/C, exhaust fans etc.) that are left on when the building is not in use. There may be opportunities to shut down systems, for instance the domestic hot water tanks, if they are not required for extended periods.

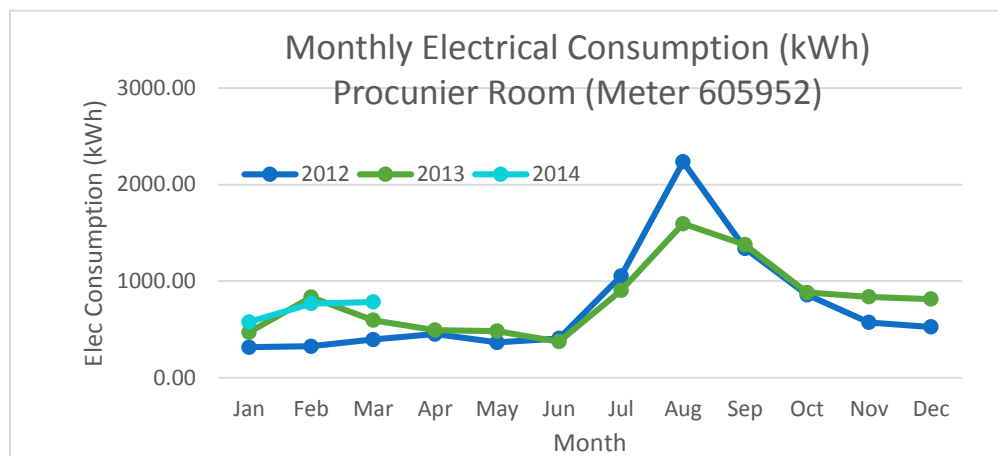
Figure 5: Historical Monthly Electricity Consumption (kWh): Proconier Room

The electrical consumption peaks (July to September) in the figure above for the Proconier room are caused by the use of air conditioning as well as increased lighting used due to the summer youth programs.

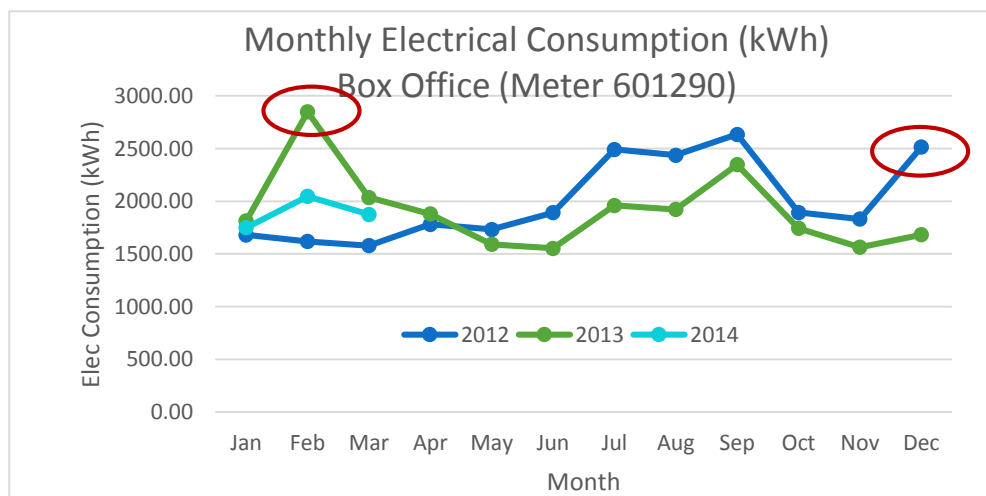
Figure 6: Historical Monthly Electricity Consumption (kWh): Box Office

The box office shows a rise in electricity use in the summer months correlating with increase air conditioning needs. Two peaks cannot be explained by the auditing team: December 2012 and February 2013. It may

be worthwhile for the staff at the Palace Theatre to determine the reason for the elevated consumption to ensure that, if preventable, they can be avoided in the future.

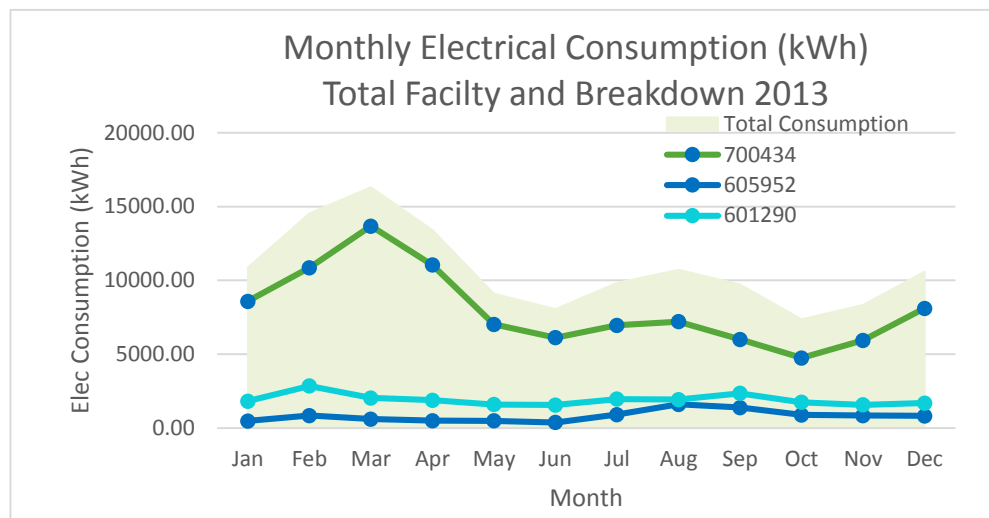
Figure 7: 2013 Monthly Electricity Consumption (kWh): Total Facility

The Theatre electrical consumption should vary significantly with cooling load and therefore would be expected to be lower in the winter and higher in the summer. The general trend on the graph above however illustrates a large electrical consumption in the December to April period which corresponds to the production season and is most likely due to stage lighting and electric heating.

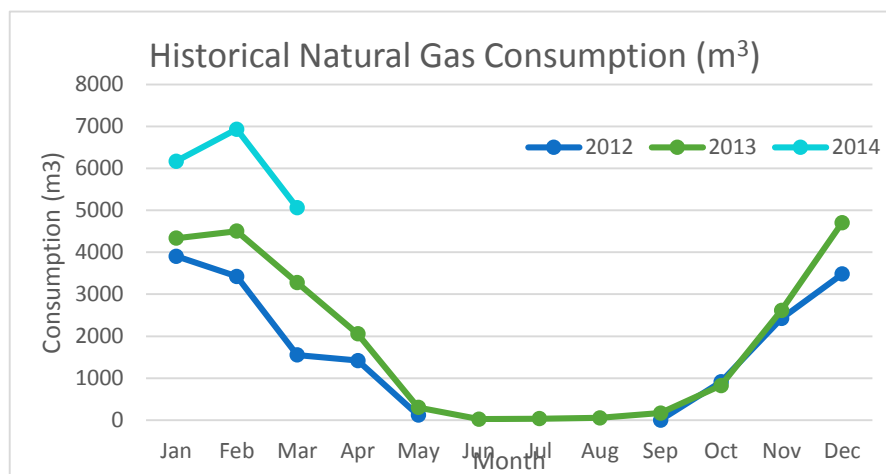
The historical natural gas consumption is shown in Figure 8 below. This data was collected from Union Gas Energy utility bills from January 2012 onward. Natural gas is used for heating all parts of the building. The graph below correlates closely with the outdoor air temperature, increasing consumption in the colder months and then dropping significantly in the summer when it is not in use.

Figure 8: Historical Natural Gas Consumption

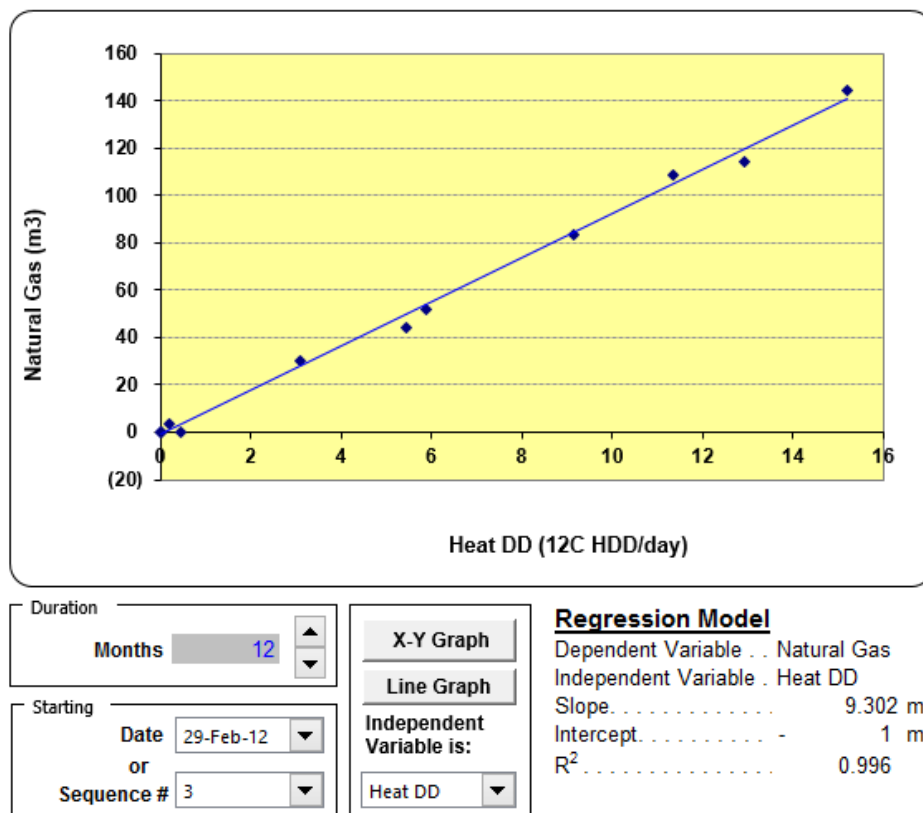
Below is an illustration of the line of best fit from monthly natural gas consumption (Mlbs) and temperature data (Heating/Cooling Degree Day (HDD/CDD)). The HDD and CDD data was obtained from the London Airport weather station. The intercept of the line of best fit and Natural gas axis (axis y) is close to zero. This indicates that natural gas is not being used at inappropriate times and all of the supply is being burned for heating.

The linear regression yielded the following relationship:

$$Y = 9.30x + 1.0$$

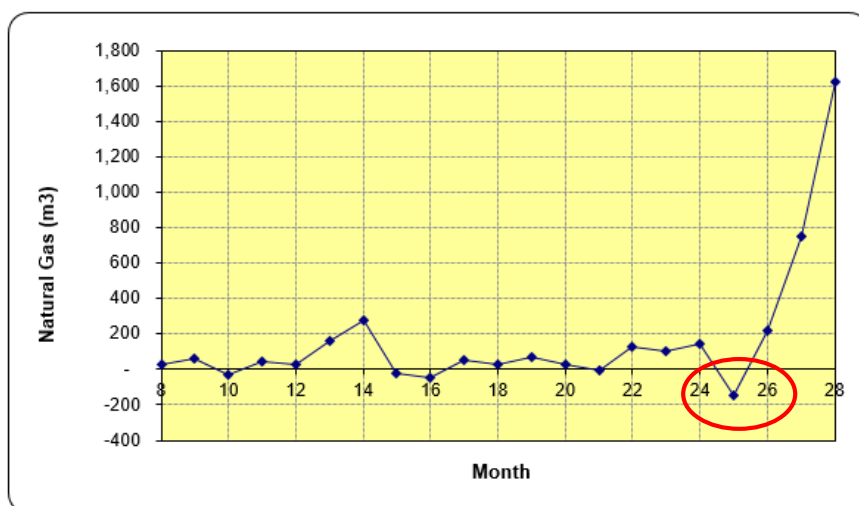
The Figure 10 below illustrates the cumulative sum trend for the natural gas consumption in this facility. The slope of the graph will be level if the facility is operating in the same manner as the baseline. A downward trend indicates that energy consumption is improving compared to baseline (due to new equipment, procedures, preventative maintenance etc.). An upward trend indicates an increase in usage.

Reviewing the trend shown in Figure 10 below, a change can be seen in the slope after point 25 (circled in red). This indicates a change in the typical consumption pattern which could be due to a variety of factors including an increase in the number of theatre productions causing the heating system to run longer or higher temperature setpoints. The pattern should not be due to weather related issues, as this has already been accounted for through the regression analysis.

Figure 10: Cumulative Sum analysis for Natural Gas Consumption

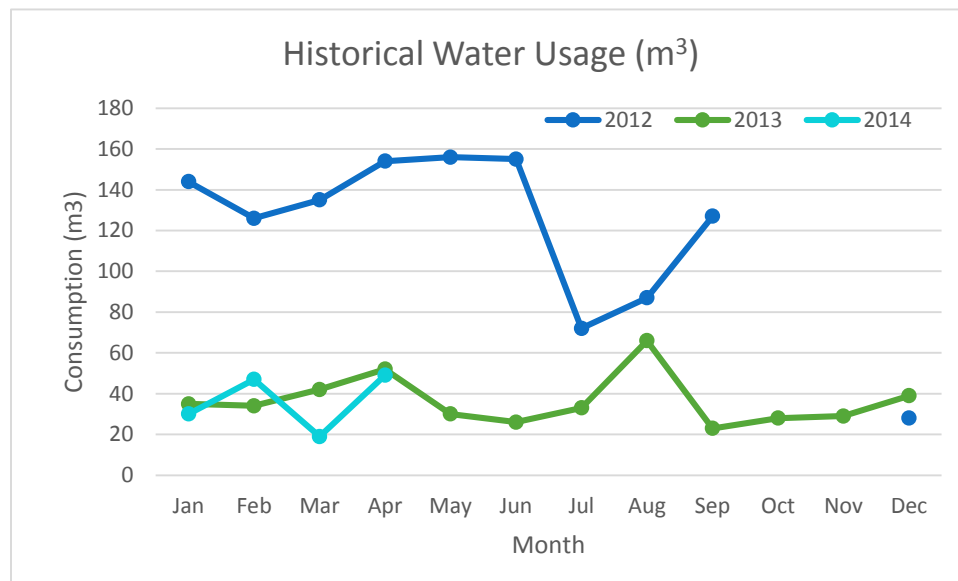
The historical water consumption data is graphed in Figure 12 below. This data was collected from London Hydro utility bills from January 2012 onward. Water consumption throughout the facility is quite low since a significant reduction in consumption in the last half of 2012. The auditors were made aware of the installation of low flow urinals in the main public washrooms which may explain the drop in consumption.

Figure 11: Historical Water Consumption

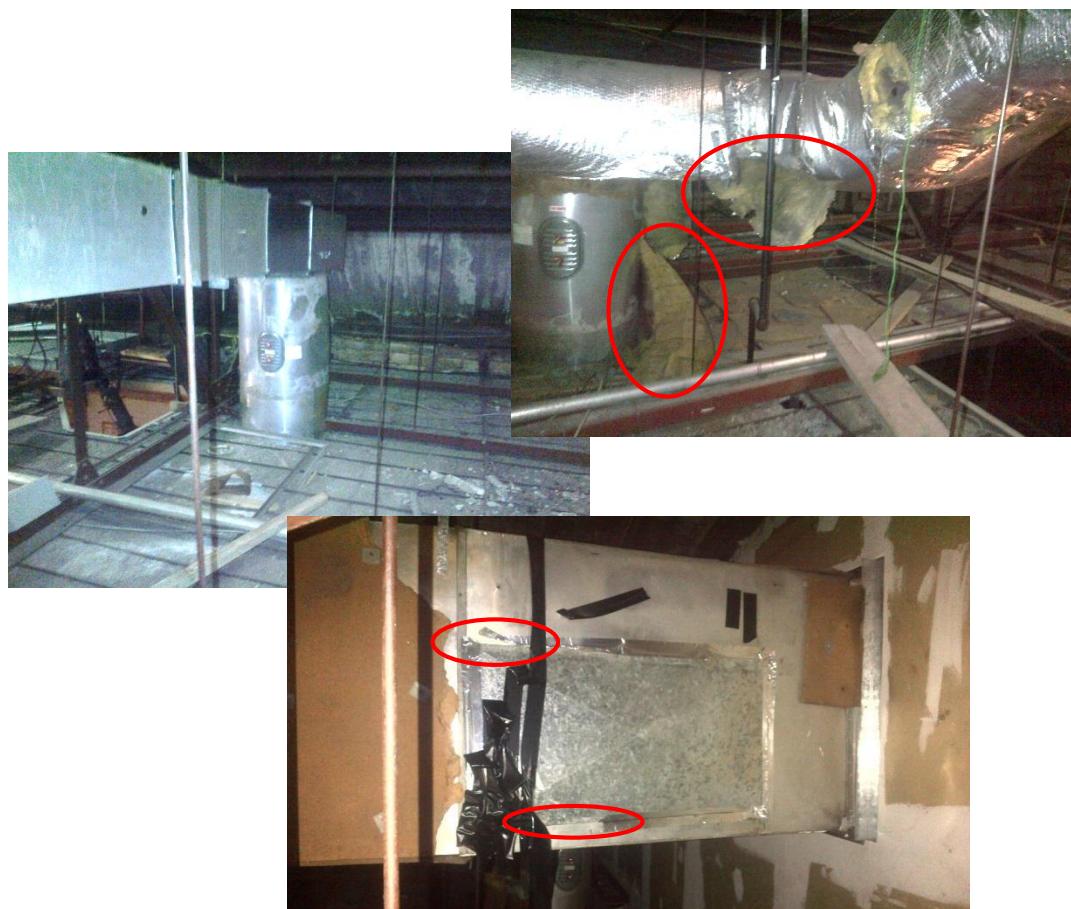
The supply air ducting located in the theatre attic (fly loft) delivers conditioned air to the theatre seating area through diffusers in the ceiling. While portions of the ducting in the fly loft are insulated, much of the main trunk line is uninsulated, causing heat loss to the attic space and reducing space temperature control. In addition, it was noted that tape was hanging loose around gaps in the ducting in several places, and insulation was beginning to become loose. Heat transfer to and from the attic space will therefore be occurring by conduction through the duct surfaces and infiltration through joints that are unsealed.

Figure 12: Supply air ducting located in the Attic (Fly loft) of the main theatre.

Given a modest savings of 5% of furnace use and 3% of cooling use, this results in a cost savings of \$334 per year. At an approximate cost of \$1,250 to repair/replace the insulation, this results in a simple payback period of 3.7 years.

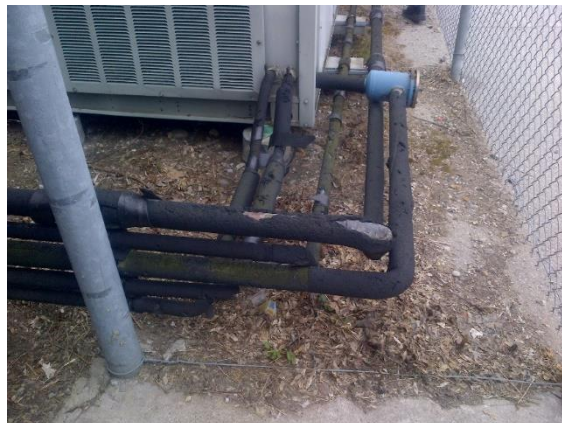
The insulation around the chiller's condensing water supply and return lines is missing around some elbows, and in other areas, is in need of repair. The lines are located outside the building at the back near the main Trane chiller. Heat transfer is significant between the chilled water line and the hot summer air if the lines are not insulated, causing the compressor to work harder.

Figure 13: Cooling coil water lines feeding in and out of Trane Chiller.

The replacement of line insulation is inexpensive, requiring approximately \$50 in materials and 1-2 hours install time. The estimated savings is approximately \$47 annually, giving a payback period of 2.8 years.

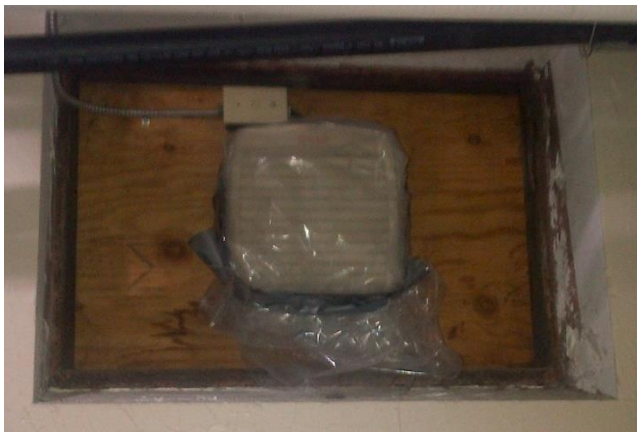
- Apply weather stripping or caulking around the edges of all windows and perimeter doors where necessary
- Replace weather stripping around the fire hatches in the roof
- Seal and insulate areas around exhaust fans

Figure 14: Exhaust fan installed in Theatre basement window.

While savings are difficult to determine without space air pressure tests, we estimate that approximately 3-5% reduction in building heat loss can be achieved through improved air sealing. A full review of all outer walls, doors and windows is recommended to address air infiltration issues with additional, caulking and

weather stripping. We estimate approximately \$500 in material costs and savings of \$260, resulting in a 1.9 year payback.

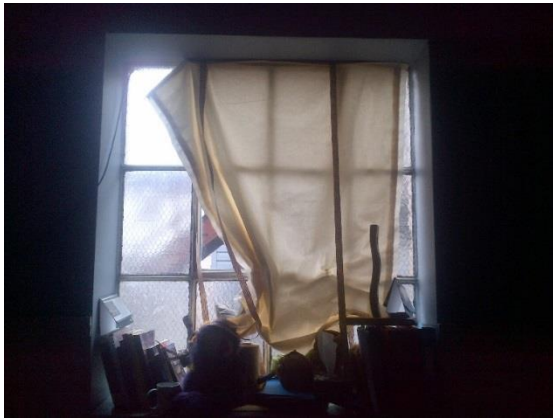
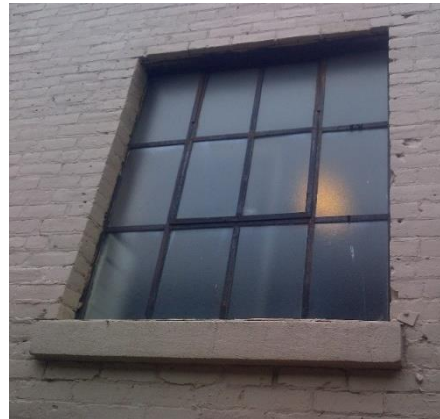
The fenestration in general manager's office behind the east conference room is an original single paned window, see Figure 15 below. Cracks are evident in the glass in the top left corner and the caulking is quite old and needs replacing. Staff mentioned that the room can be quite cold in the winter and therefore the thermostat that controls heat to this office along with the box office and conference room is set higher in the winter to provide heat to this space.

Significant heat transfer occurs through the surface of single paned windows and infiltration is also a concern if there are holes or cracks in the glass surface or caulking. Energy savings should be significant if this window was replaced with a new window which is triple glazed, argon filled with a low emissivity coating and a warm edge spacer. It would not only make the room more pleasant in the heating and cooling season, but would allow the reduction in space heating / cooling for the whole box office area as the thermostat set point is increased in order to ensure this back room is warm.

Figure 15: General Manager's office window.

We estimate the cost of replacing the window is \$1,304. A quote is attached in Appendix A. It is recommended that the new window be triple glazed, argon filled with a low emissivity coating and a warm edge spacer. The cost is based on a quote from a local commercial supplier (FibreTec) and is of Class 5 accuracy (+/- 50%).

The savings are estimated as \$110 annually and as such, the savings do not justify the replacement of the existing window. We suggest that the window be inspected to ensure the outer pane caulking is truly sealed and in good repair. While immediate replacement is not justified by energy savings alone, it should be noted that the additional cost of upgrading to high efficiency over standard windows is easily covered by the additional savings.
